Investigation of Concrete from I-20 Near Monroe, Louisiana

by G. Sam Wong

Final report

Prepared for U.S. Army Corps of Engineers Washington, DC 20314-1000

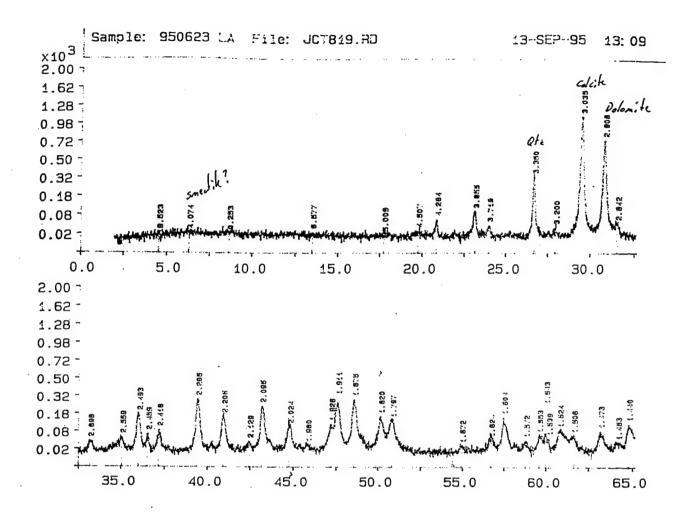
Figure 16. X-ray diffraction pattern of reactive coarse-aggregate particle from core 950623

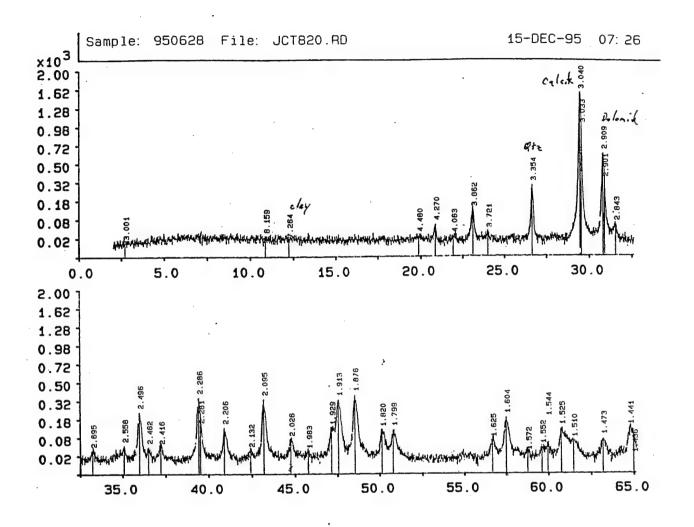
dark-gray fine-grained limestone coarse-aggregate particles in the concrete. Some of the pieces were large coarse-aggregate particles and some were small. Cracks were always associated with the larger pieces of aggregate of this nature and were less common with smaller pieces. Many of these pieces of aggregate showed open cracks in the interior of the particle. The X-ray diffraction pattern showed the coarse-aggregate particles to consist of a dolomitic limestone containing some quartz and clay (Figure 17).

Figure 17. X-ray diffraction pattern of reactive coarse-aggregate particle from core 950628

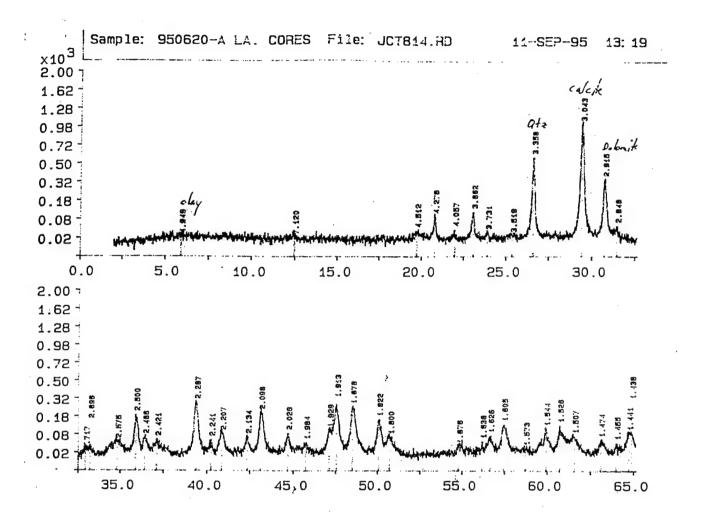
- f. 950620 The core was cracked throughout its length. The cracks were randomly oriented. There were numerous dark-gray limestone coarse-aggregate particles with dark reaction rims. The rims exhibited radial cracks that extended into the paste. Aggregate particles with these rims were dolomitic limestone containing quartz and clay. X-ray diffraction patterns are presented in Figures 18 and 19. Figure A6, Appendix A, shows the appearance of these aggregate particles.

Figure 18. X-ray diffraction pattern of reactive coarse-aggregate particle #A from core 950620

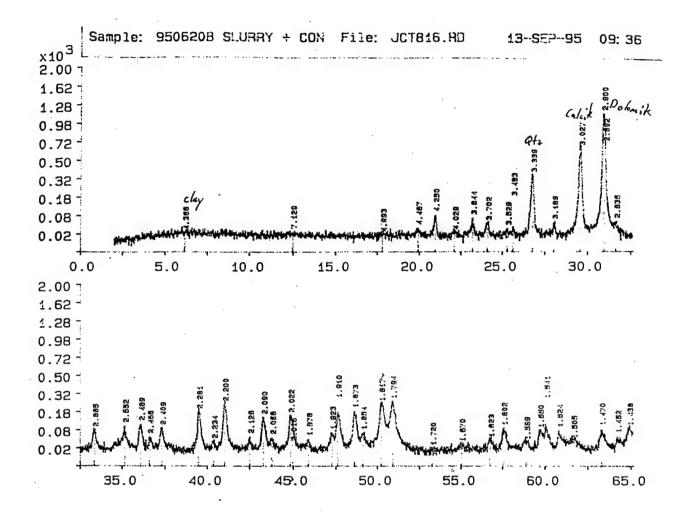
Figure 19. X-ray diffraction pattern of reactive coarse-aggregate particle #B from core 950620.

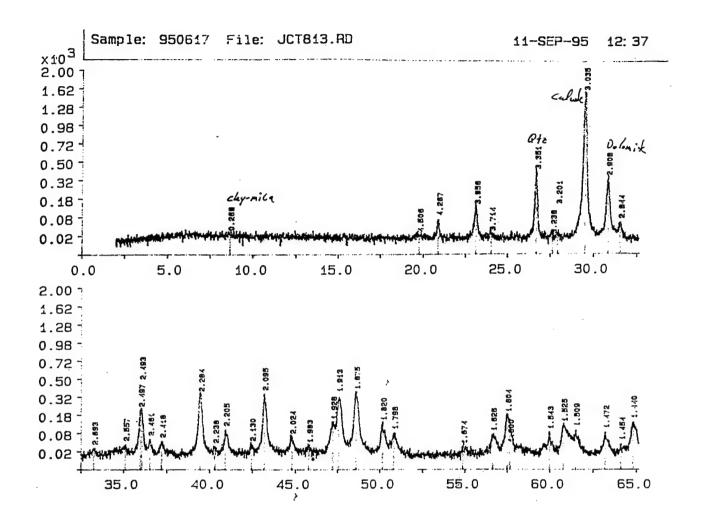
- h. 950617 This sample consisted of rubble. The core had broken into fragments during the coring process. One large piece was impregnated using an epoxy resin and then cut open for examination. The concrete was highly fractured (Figure A8, Appendix A). There were numerous dark-gray limestone coarse-aggregate particles. Cracks were mostly associated with the larger coarse-aggregate particles. The associated dark-gray coarse-aggregate particles were dolomitic limestone containing some quartz as well as illite (claymica). An X-ray diffraction chart showing the relative abundance of the calcite and dolomite is presented in Figure 20.

Figure 20. X-ray diffraction pattern of reactive coarse-aggregate particle from core 950617

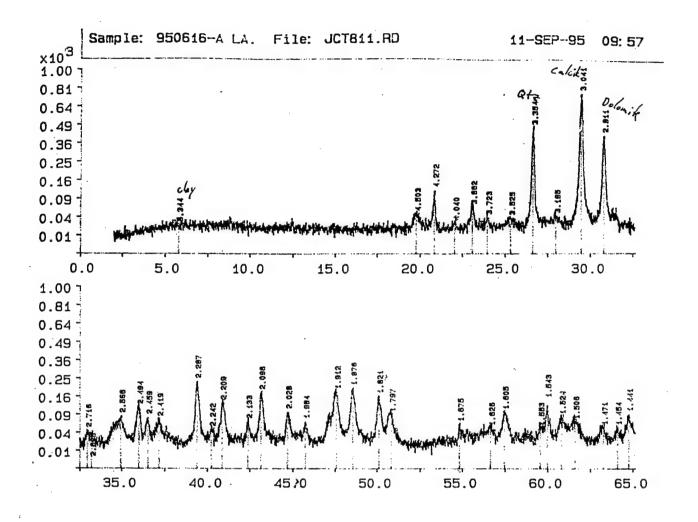
- j. 950616 The surface cracking was light. However, the interior concrete showed an extensive crack system. A vertical crack extended several inches into the interior concrete going through coarse-aggregate particles as well as around them. The vertical cracks intersected horizontal and diagonal cracks (Figures A9a and A9b, Appendix A). The majority of the cracks were associated with cracked dark-gray fine-grained limestone coarse-aggregate particles. Two particles examined by X-ray diffraction were dolomitic limestone with acid-insoluble materials consisting of quartz and clays. Figures 21 and 22 illustrate the relative abundance of the carbonate phases.

Figure 21. X-ray diffraction pattern of reactive coarse-aggregate particle #A from core 950616

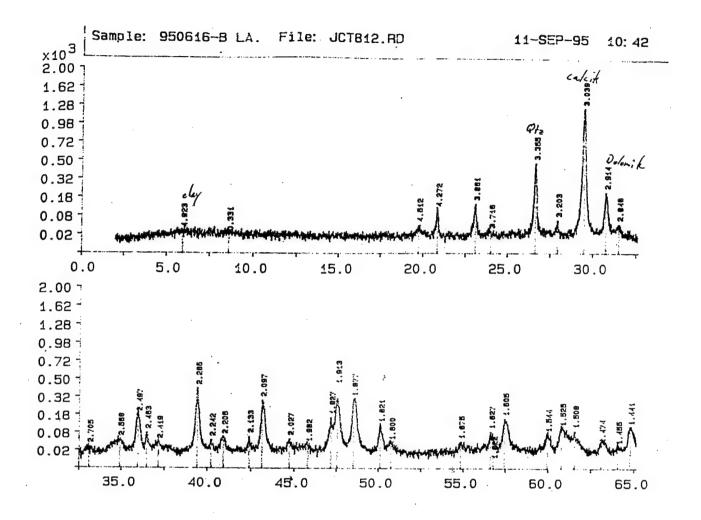
Figure 22. X-ray diffraction pattern of reactive coarse-aggregate particle #B from core 950616

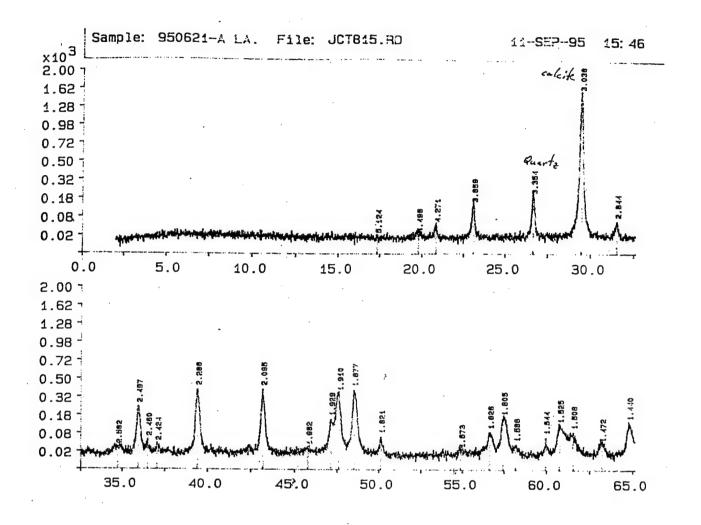
- m. 950621 This concrete had some hairline cracks at the surface. One crack penetrated into the interior concrete approximately 1 in. (25.4 mm) and terminated in the paste. The upper portion of the concrete consisted of lighter colored limestone coarse-aggregate particles. The lower portion of the core contained numerous dark-limestone coarse-aggregate particles with dark reaction rims. Some cracks associated with these limestone aggregate particles are shown in Figure A12, Appendix A. The X-ray diffraction pattern of aggregate particle #A, a dark-gray particle with a prominent dark reaction rim, showed it to be pure limestone, as shown in Figure 23. Light-colored brownish limestone with a reaction rim (particle #B) was pure limestone, as identified in Figure 24. The dark-gray particle

Figure 23. X-ray diffraction pattern of non-expansive reactive coarse-aggregate particle #A from core 950621

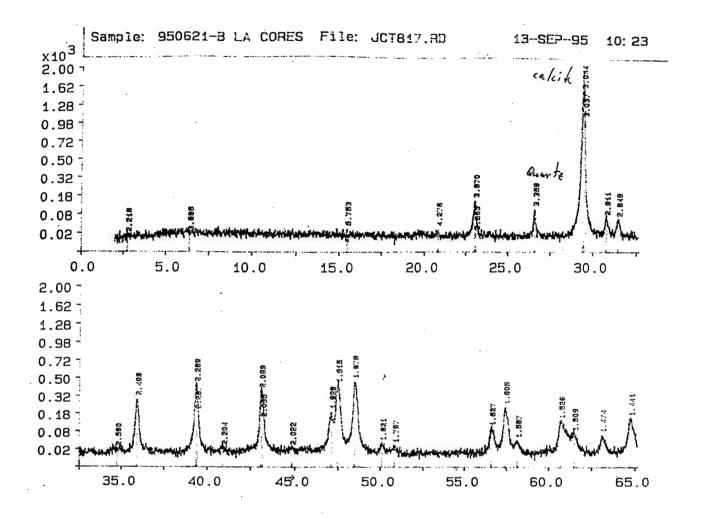
Figure 24. X-ray diffraction pattern of non-expansive reactive coarse-aggregate particle #B from core 950621

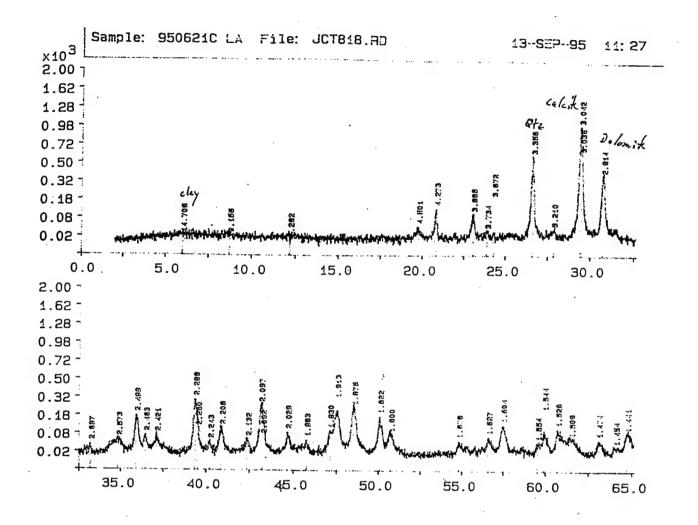
with a prominent reaction rim (Figure A12, Appendix A) (particle #C) was a fine-grained dolomitic limestone also containing insoluble material including clays and quartz (Figure 25). A thin section of a near-surface dark-gray fine-grained impure limestone coarse-aggregate particle showed a rim on this aggregate and micro cracks in the rim propagating into the paste. Etching of coarse-aggregate particle using dilute hydrochloric acid showed no relief in the rim area; i.e., the rim was neither more nor less acid soluble than the unaltered rock.

Figure 25. X-ray diffraction pattern of expansive reactive coarse-aggregate particle #C from core 950621

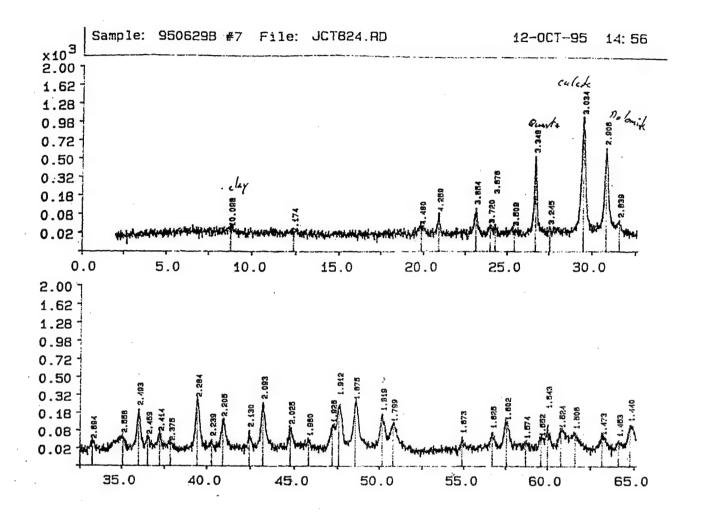
Rock-cylinder expansion measurements indicated that some of the aggregate particles were highly reactive when stored in sodium hydroxide in accordance with ASTM C 586. Figures 28 and 29 show expansion data up to 64 days. The specimens were immersed in water for 7 days and showed no change in length. Specimens from both limestone samples included aggregate materials that expanded significantly. Sample 950629 showed immediate expansion and rose to above 3 percent at 35 days; measurements were terminated for these particular specimens as they began to fall apart. Sample 950630 yielded specimens that expanded to above 0.4 percent in 64 days in sodium hydroxide. Analysis of a highly expansive particle in 950629 (particle B) indicated the sample to be composed of dolomitic limestone containing some quartz and clay. No reaction products were detected by X-ray diffraction analysis, as shown in Figure 26.

Figure 26. X-ray diffraction pattern of highly reactive coarse-aggregate particle #B from limestone sample 950629 after treatment in sodium hydroxide

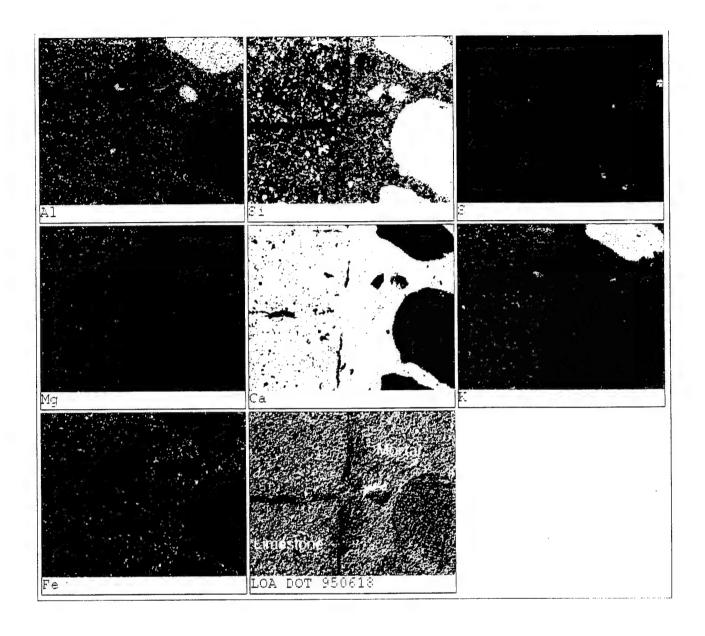
- 950618 This concrete was heavily cracked. Vertical, horizontal, and diagonal cracks were abundant throughout the length of core. The cracking was associated with a large dark-gray limestone coarseaggregate particle (Figure A11, Appendix A). Fractures were observed in the central portion of the aggregate particle as well as in the rim area of the particle. A specimen of this aggregate particle was cored along the paste-to-aggregate interface and prepared for examination as a ground section. The specimen was impregnated using an epoxy resin to reinforce the sample and minimize possible additional cracking in the preparation process. The specimen showed the propagation of cracks through the interface zone. The cracks were not confined to the interface zone of the aggregate particle as they propagated into the interior of the aggregate particle. The interior portion of the aggregate particle was also cracked. High-resolution elemental analysis using the scanning electron microscope (SEM) and energy dispersive X-ray (EDX) showed no migration of elements in this particular aggregate particle, as illustrated in Figure 27.

Figure 27. High-resolution X-ray elemental map of reactive coarse aggregate interface with paste. No migration of elements is observed

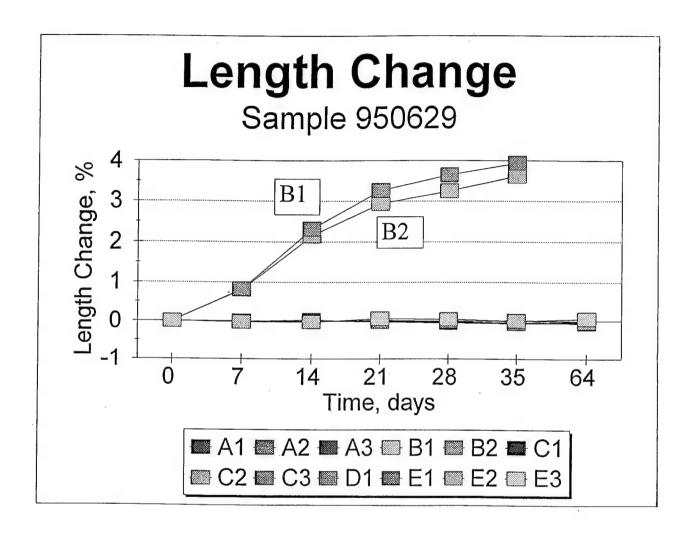
Figure 28. Rock cylinder test shows two specimens (B1 and B2) from sample 950629 expanding quickly while others did not expand. Cores were taken from five particles (A, B, C, D, and E) representing varieties of rock

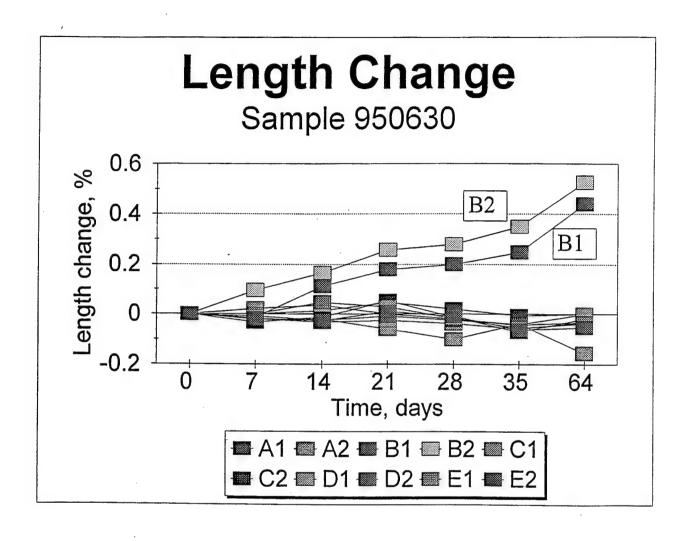
Figure 29. Rock cylinder test shows two specimens (B1 and B2) from sample 950630 expanding while others did not expand. Cores were taken from five particles (A, B, C, D, and E) representing varieties of rock

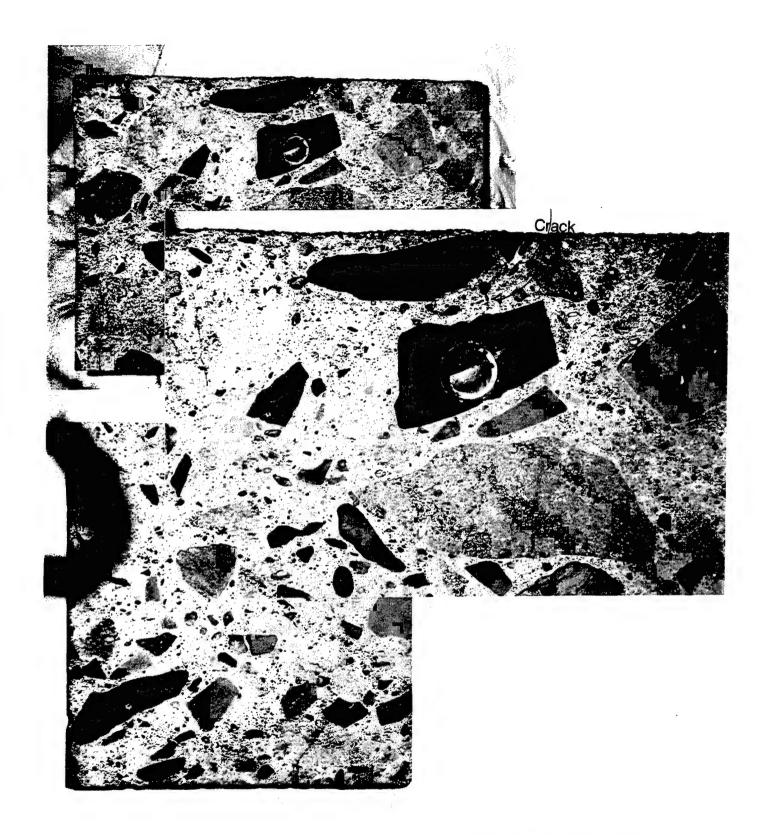
- a. 950623 This core was cut along its entire length to expose the interior concrete. A near-surface vertical crack was associated with subsurface dark-gray coarse-aggregate particles with prominent reaction rims. These particles showed some interior cracks. X-ray diffraction examination of one particle indicated that the particle was composed of a fine-grained dolomitic limestone containing some quartz and clay, as shown in Figure 16. Some interior, randomly oriented incipient cracks were also observed associated with dark-gray coarse-aggregate particles with reaction rims, as illustrated in Figure A1, Appendix A. These cracks were located in the lower portion of the core.

Figure A1. Sample 950623 shows reactive particles 1 and 2 near top surface associated with cracks. The top and bottom samples are 6 in. (152 mm) left to right

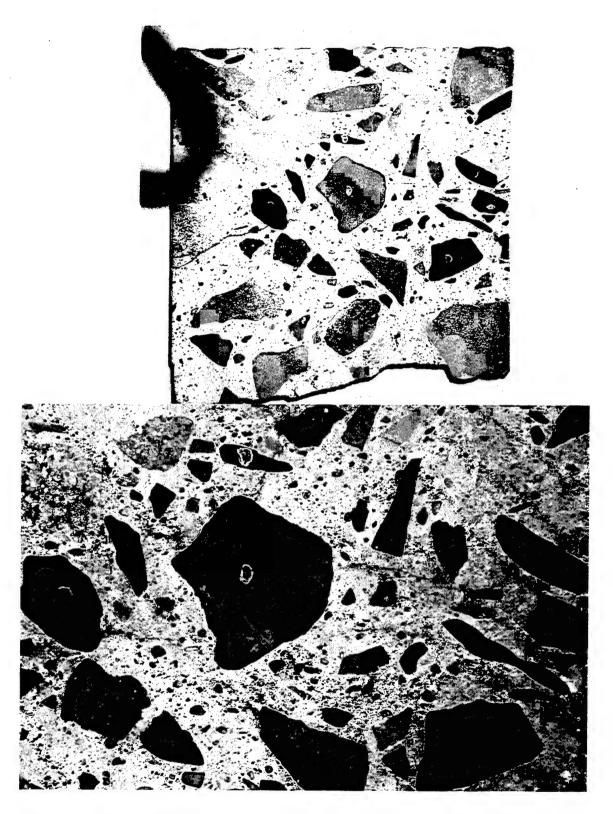
- b. 950625 Vertical cracks from the surface intersected dark-gray coarse-aggregate particles as well as horizontal intermittent fractures, as shown in Figure A2, Appendix A. All fractures could be traced to dark-gray coarse-aggregate particles with dark reaction rims either partially or entirely rimming the particle. No cracking was associated with similar smaller dark coarse-aggregate particles. Cracks in some particles were continuous into the paste while other cracks in the aggregate particles showed no such continuation. The paste was hard and intact.

Figure A2. Sample 950623 shows a random crack pattern with cracks propagating from central reactive coarse aggregate. Other reactive aggregate particles are also present. Top sample is 6 in. (152 mm) left to right

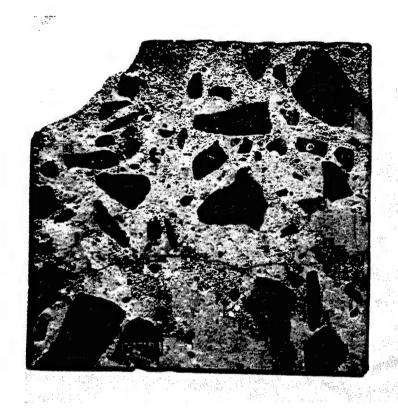
- c. 950626 This concrete sustained localized damage. A single horizontal crack and some hairline fracturing were observed on a cut section on one side of the slab (Figure A3a, Appendix A). On the reverse side, heavy fracturing of the concrete associated with dark-gray coarse-aggregate particles was observed. Minor cracking at the bottom of the core associated with cracked dark-gray coarse aggregate is illustrated in Figure A3a, Appendix A. Examination of a thin section containing coarse-aggregate particles showed a linear opening along oriented features. The cracks contained no observed reaction products.

Figure A3a. Sample 950626 shows some interior cracking in the concrete and a few small reactive particles with reaction rims. The sample is 6 in. (152 mm) left to right

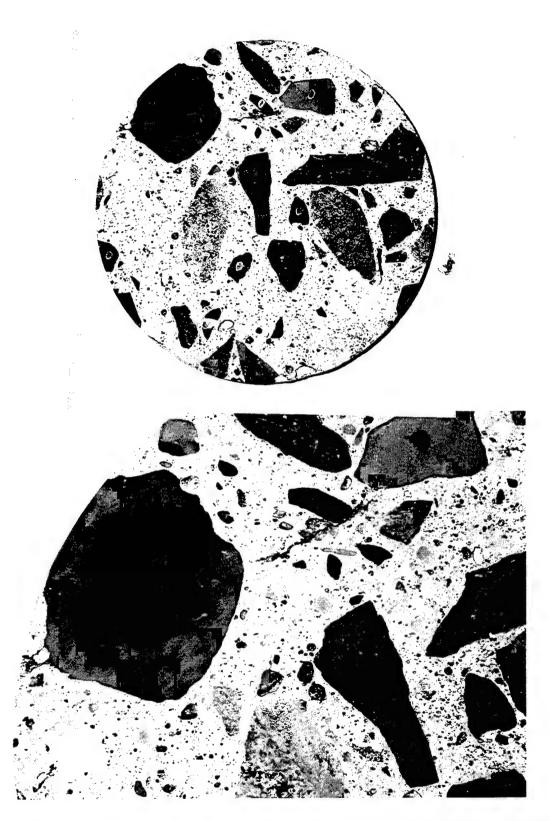
Figure A3b. Sample 950626 shows reactive aggregate particles at bottom of core. The sample is 6 in. (152 mm) left to right

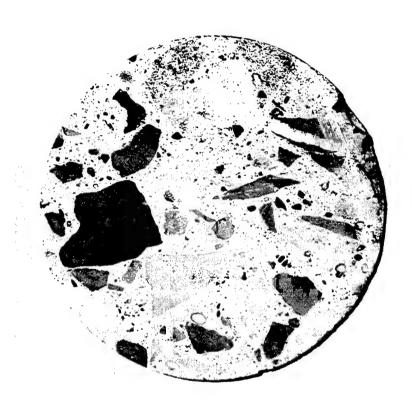
Figure A4. Sample 950627 shows no cracks. The sample is 6 in. (152 mm) left to right

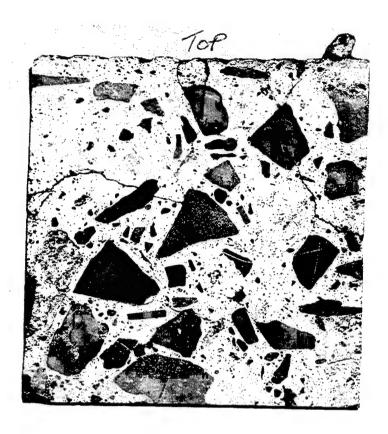
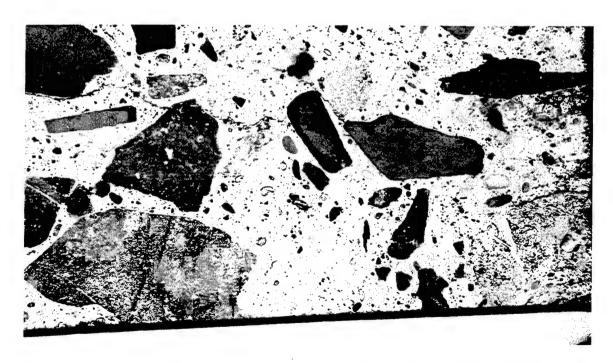
- e. 950628 The concrete contained numerous cracks throughout the length of the core. The cracks were vertical, horizontal, and diagonal going through, as well as around, coarse-aggregate particles, as shown in Figures A5a and A5b, Appendix A. There were numerous

Figure A5a. Sample 950628 shows severe cracking in near surface concrete. Epoxy resin fills the cracks. Top sample is 6 in. (152 mm) left to right

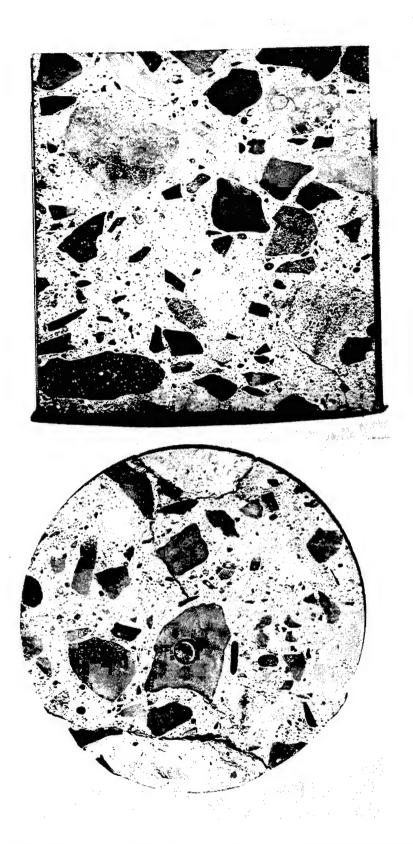
Figure A5b. Sample 950628 shows cracking is continuous throughout the entire length of core. Both samples are 6 in. (152 mm) left to right

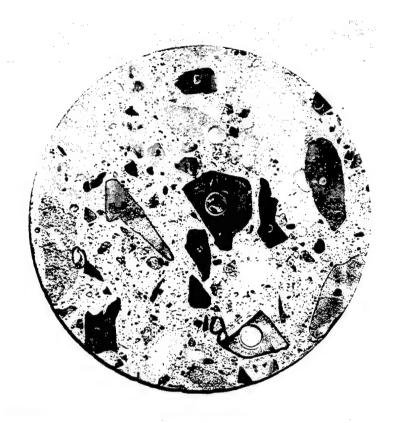
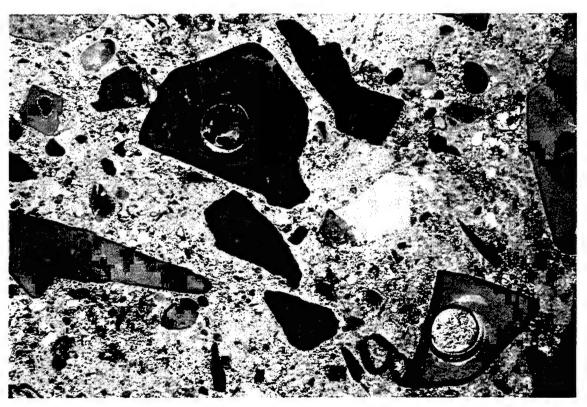
Figure A6. Sample 950620 shows aggregate reaction at the base of the core. Cracks are visible along the reaction rim. Top sample is 6 in. (152 mm) left to right

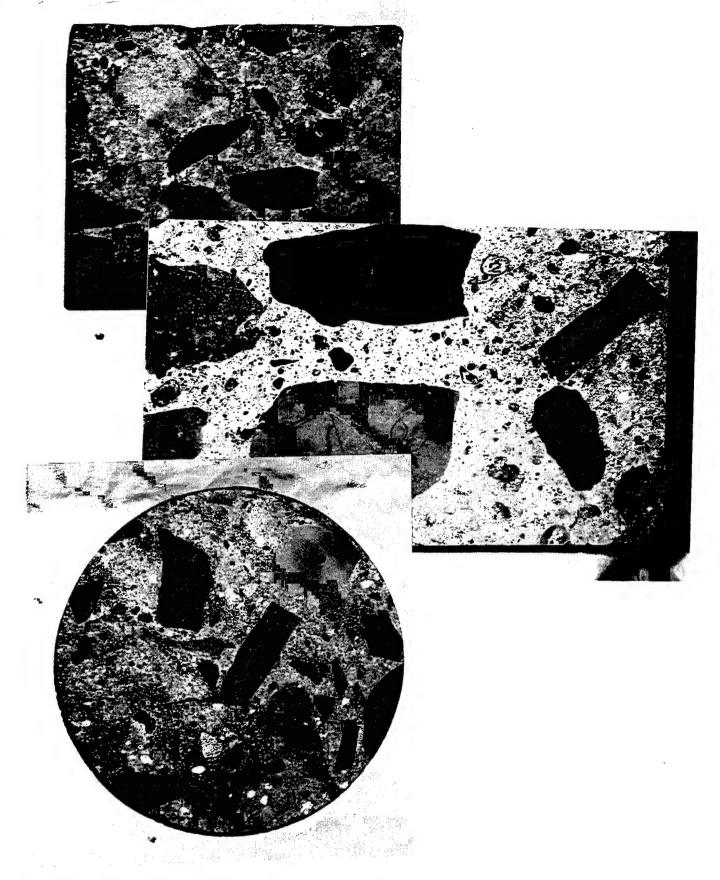
- g. 950619 The core was cracked throughout its length. Cracking in the near-surface concrete was more severe as vertical, horizontal, and diagonal cracks were common and associated with dark-gray limestone coarse-aggregate particles (Figure A7, Appendix A). Thin sections of two coarse-aggregate particles were prepared. Particle #A was a light-colored fine-grained limestone consisting of a fine-grained matrix and rhombohedral dolomite crystals. No cracks associated with this particle were observed. Particle #B was a dark-gray fine-grained limestone with a rim around it and was associated with cracking. No difference could be observed between the material in the rim and the interior of the particle. Fine quartz grains were embedded in a calcite matrix.

Figure A7. Sample 950619 shows random crack pattern with cracks propagating from two central reactive coarse-aggregate particles and cracking in bottom end of sample. Top and bottom samples are 6 in. (152 mm) left to right

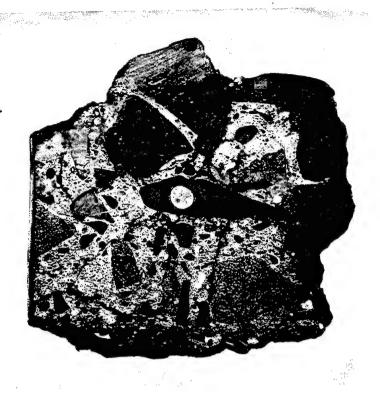
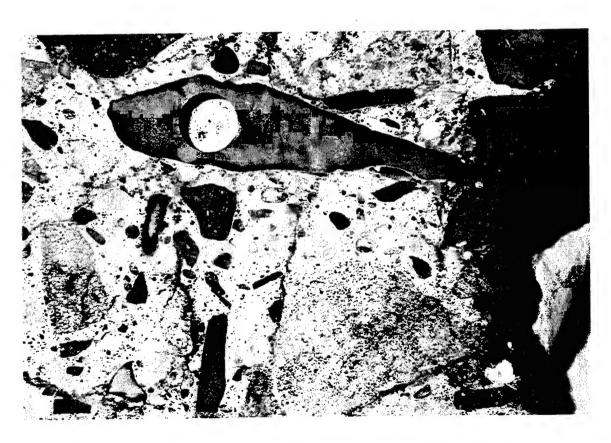
Figure A8. Sample 950617 shows a reactive aggregate particle and cracking of rim zone. Diameter core boring is 11 mm

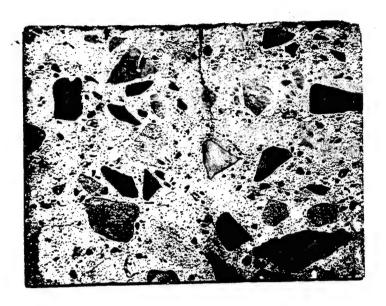
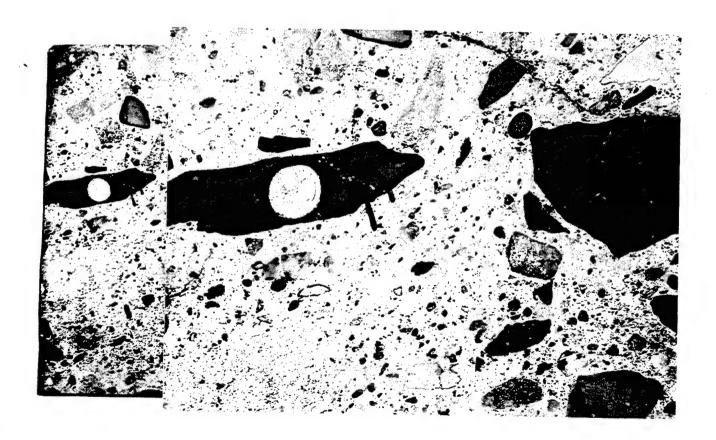
Figure A9a. Sample 950616 shows a central vertical near-surface crack and some incipient cracks associated with aggregate particle A. Samples on left are 6 in. (152 mm) left to right

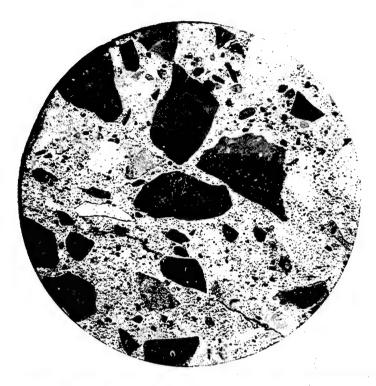
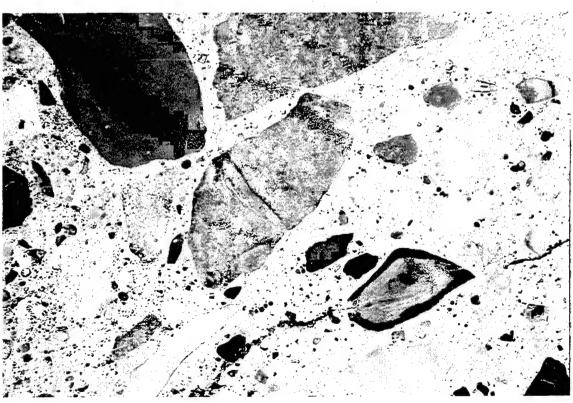
Figure A9b. Sample 950616 shows bottom of core and crack associated with reactive aggregate particle. Top sample is 6 in. (152 mm) left to right

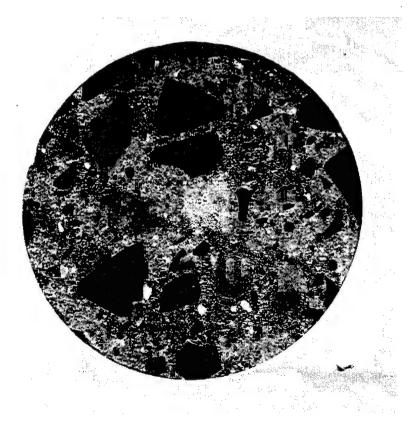
- k. 950622 This sample was intact with no visible cracks. The coarse aggregate was light colored and did not contain any reaction rims (Figure A10, Appendix A). A single hairline crack at the bottom of the core, shown in Figure A10, Appendix A, was observed and seems unrelated to dark-gray coarse aggregate.

Figure A10. Sample 950622 shows intact concrete with mostly light-colored aggregate particles. Bottom slice of core contains hairline crack. Both samples are 6 in. (152 mm) left to right

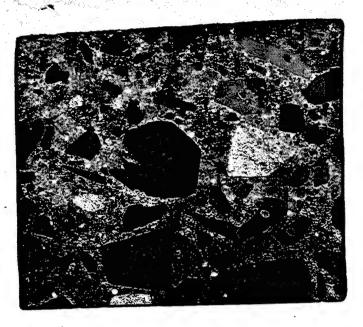
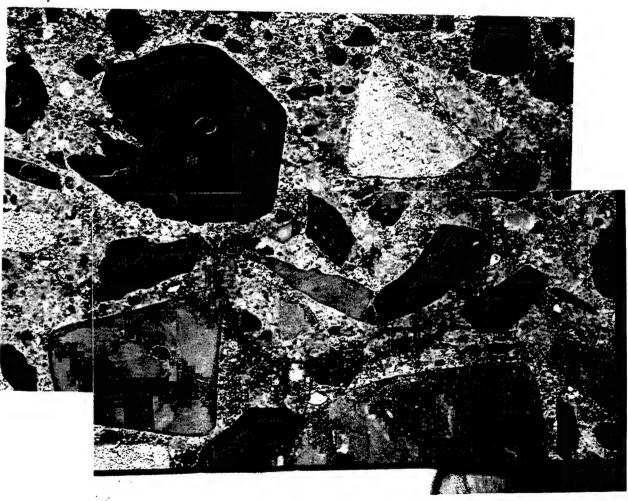
Figure A11. Sample 950618 shows random crack pattern with cracks propagating from central reactive coarse-aggregate particle. Other reactive particles are also evident. Top sample is 6 in. (152 mm) left to right

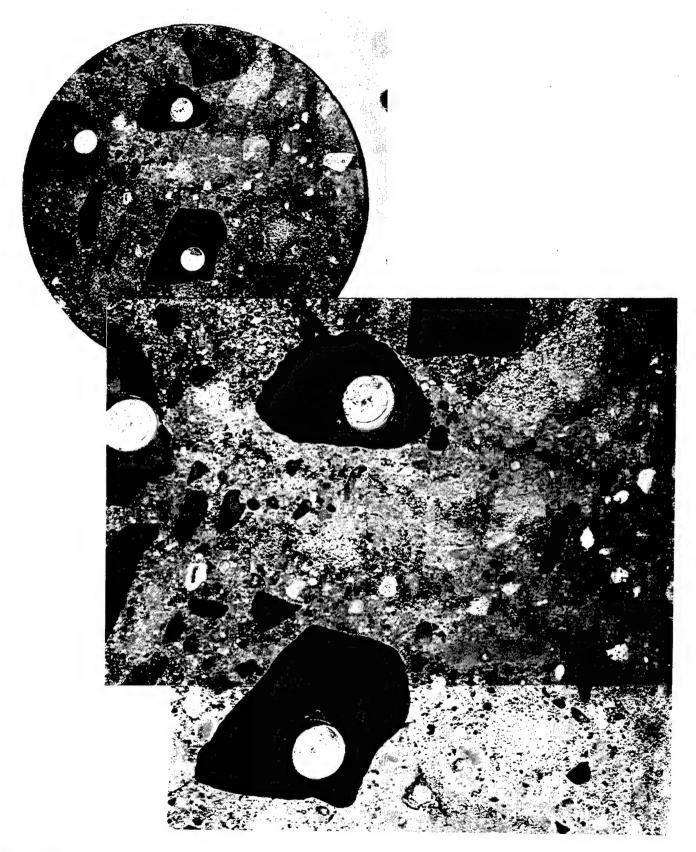
Figure A12. Sample 960621 shows aggregate particles A, B, and C. A is non-expansive, B is non-expansive, and C is expansive. Top sample is 6 in. (152 mm) left to right

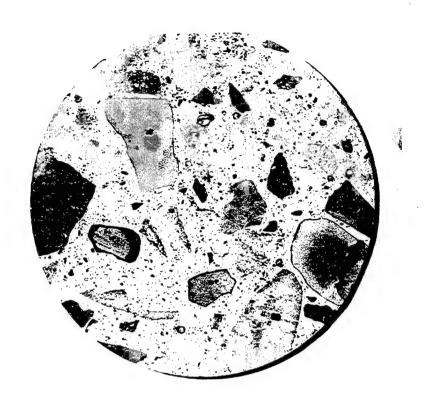
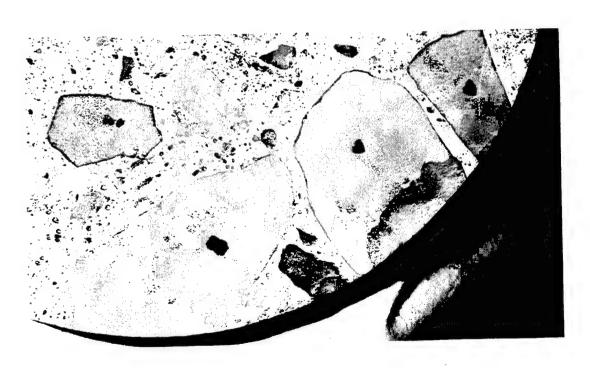
Figure A13. Sample 950615 shows some non-expansive reactive aggregate particles. Top sample is 6 in. (152 mm) left to right
